# **Selected Images of the Effects of the October 15, 2006, Kīholo Bay-Māhukona, Hawai‘i, Earthquakes and Recovery Efforts**

Data Series 506

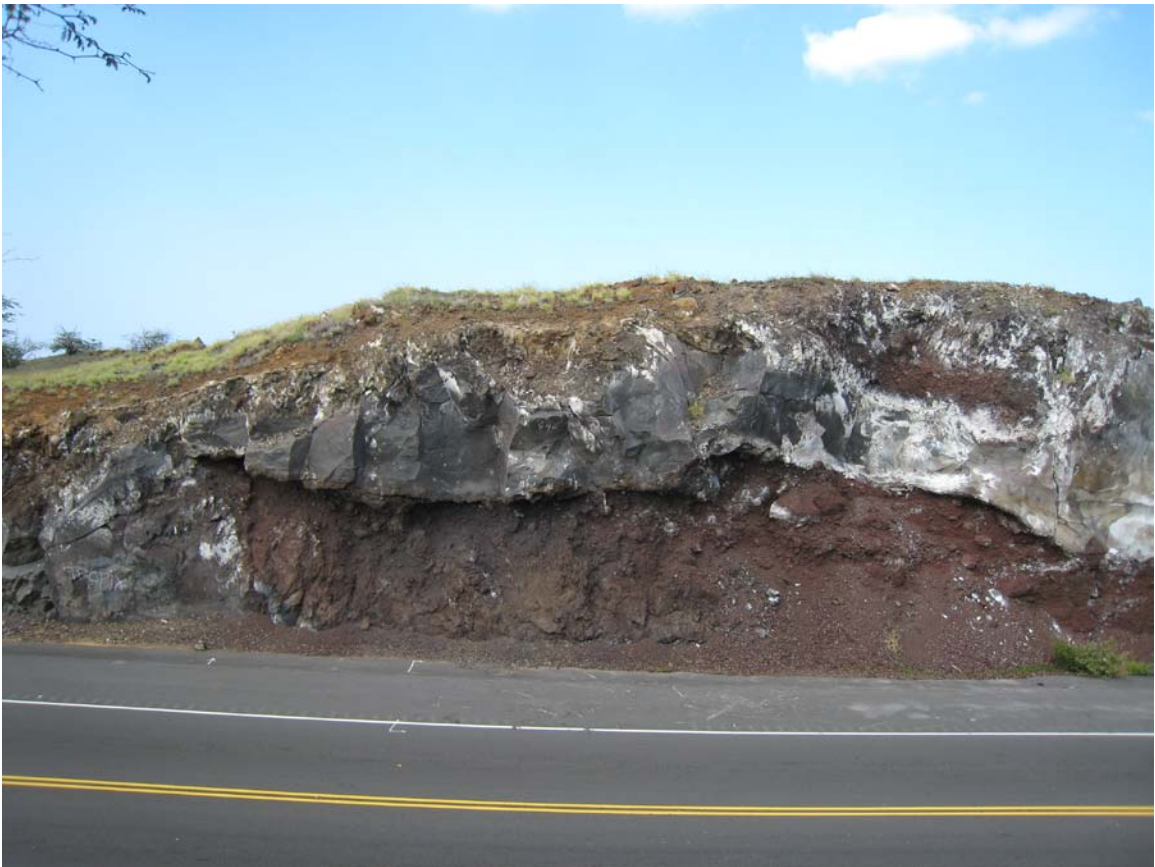
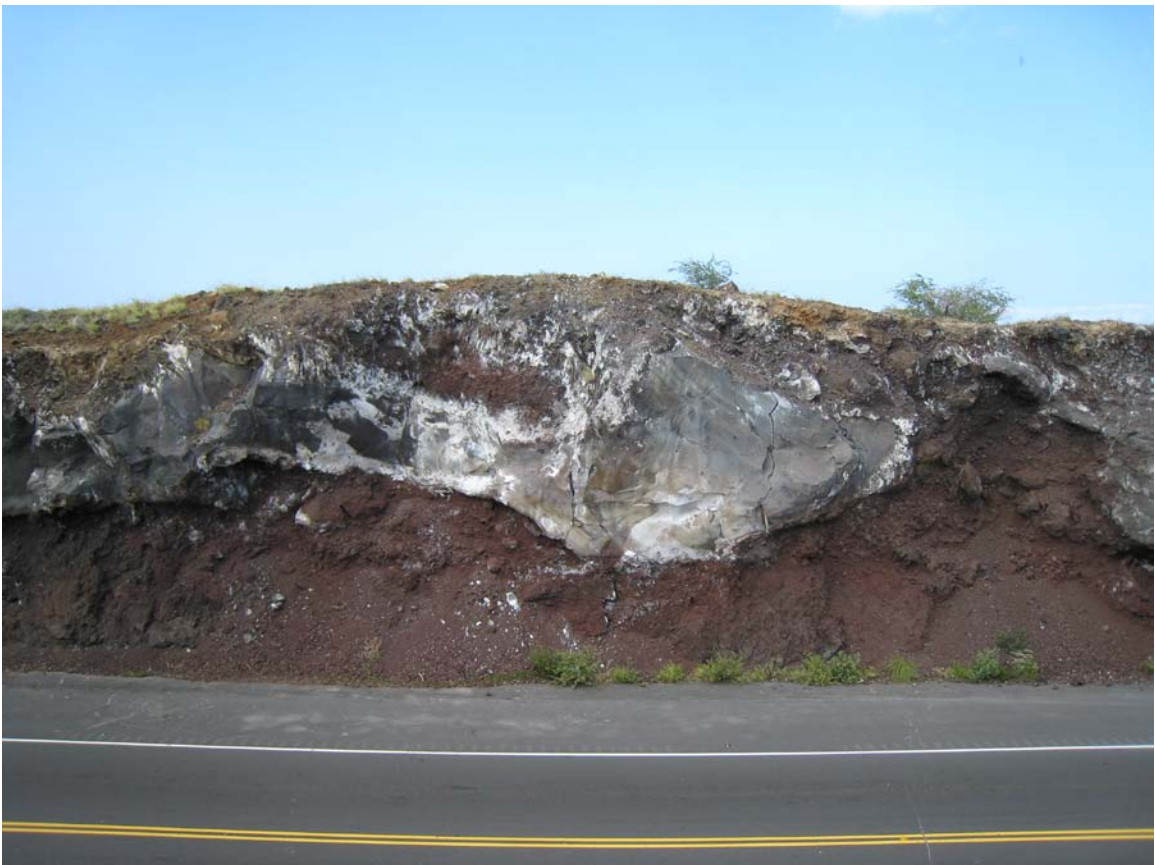
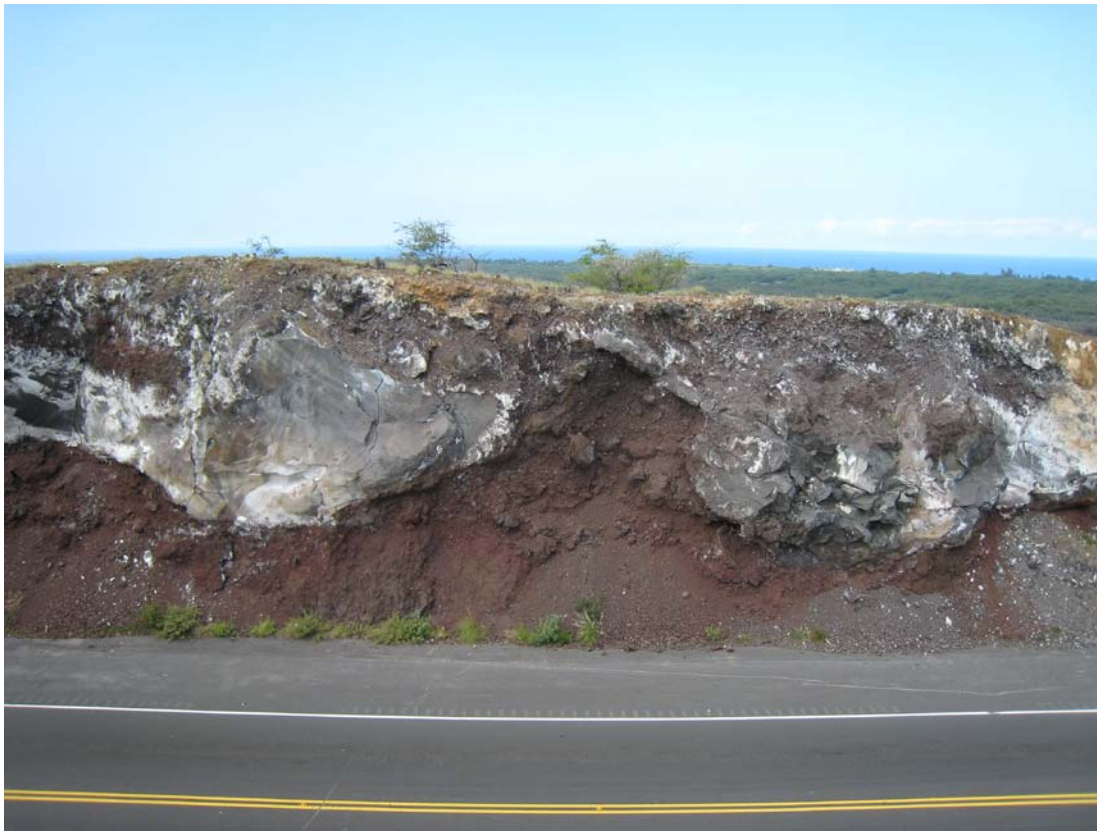
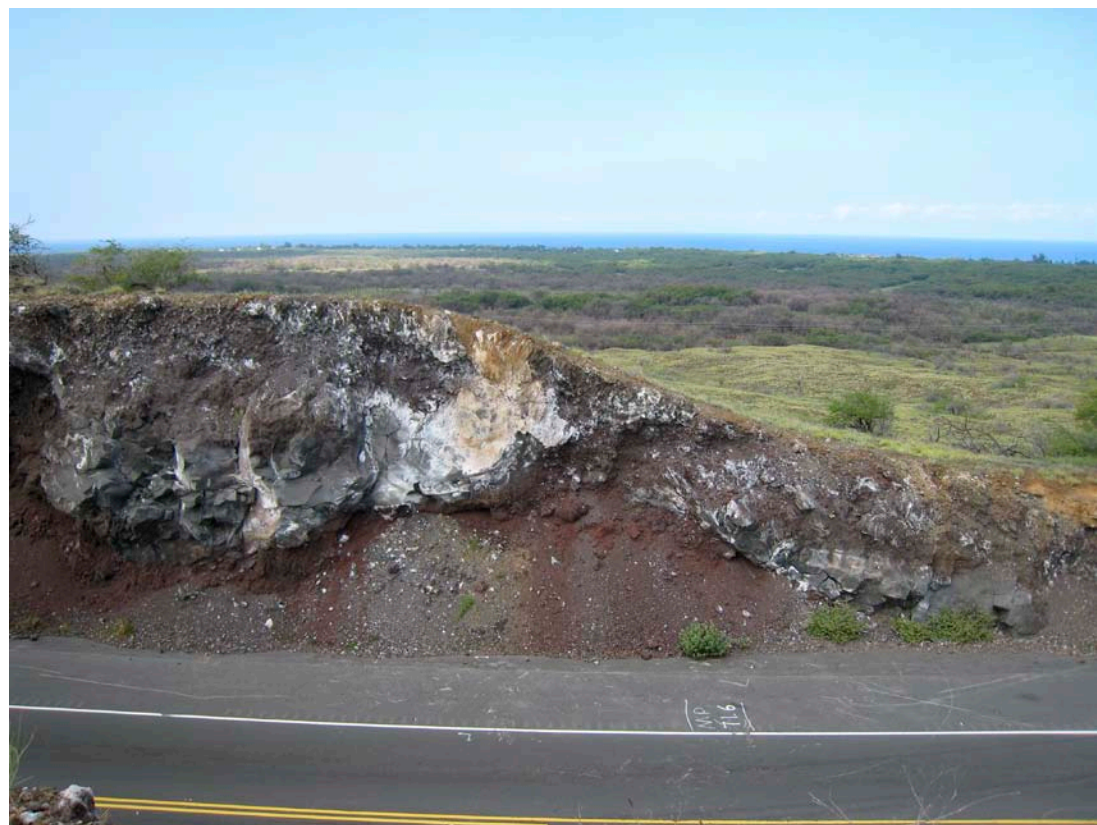
31.2–31.5. *Overview image*: A panorama of road cuts showing a soil-‘a‘ā layer over the dense core of an ‘a‘ā flow (view to the west). USGS photo by T.J. Takahashi, 1/24/2009 (tjt1112, tjt1111, tjt1115, and tjt1117).

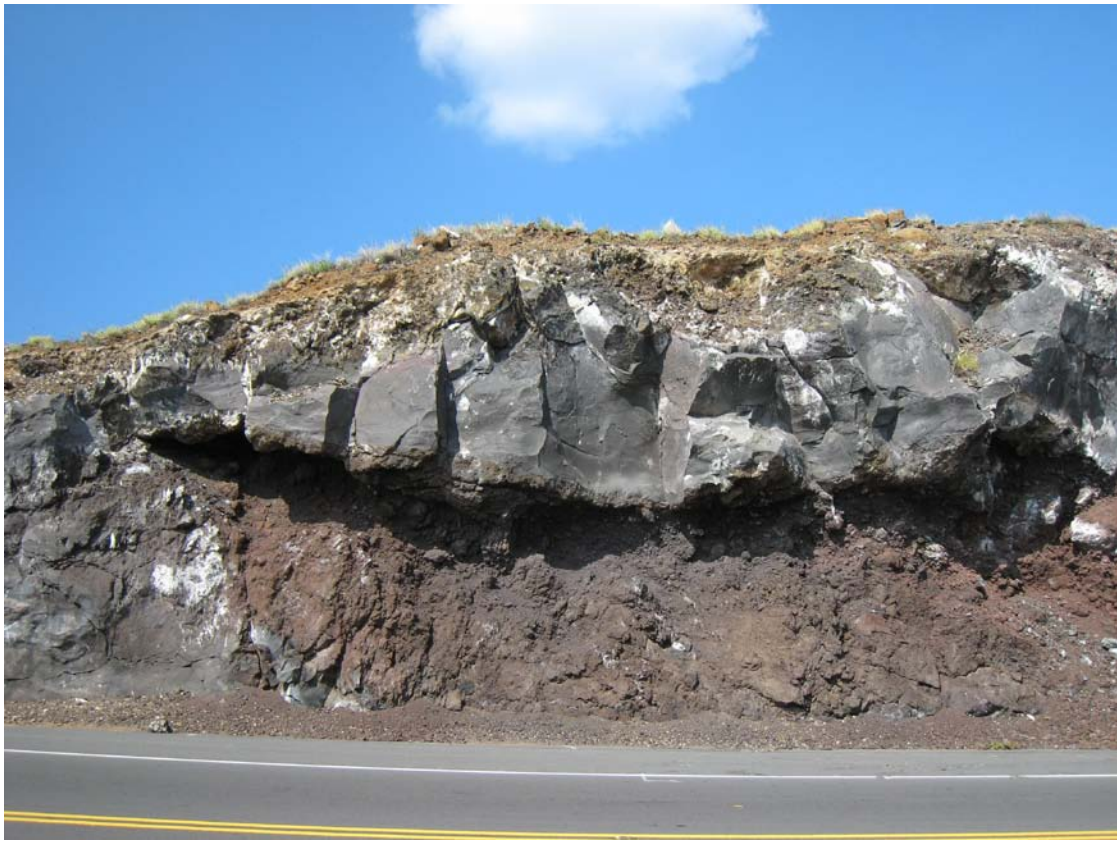
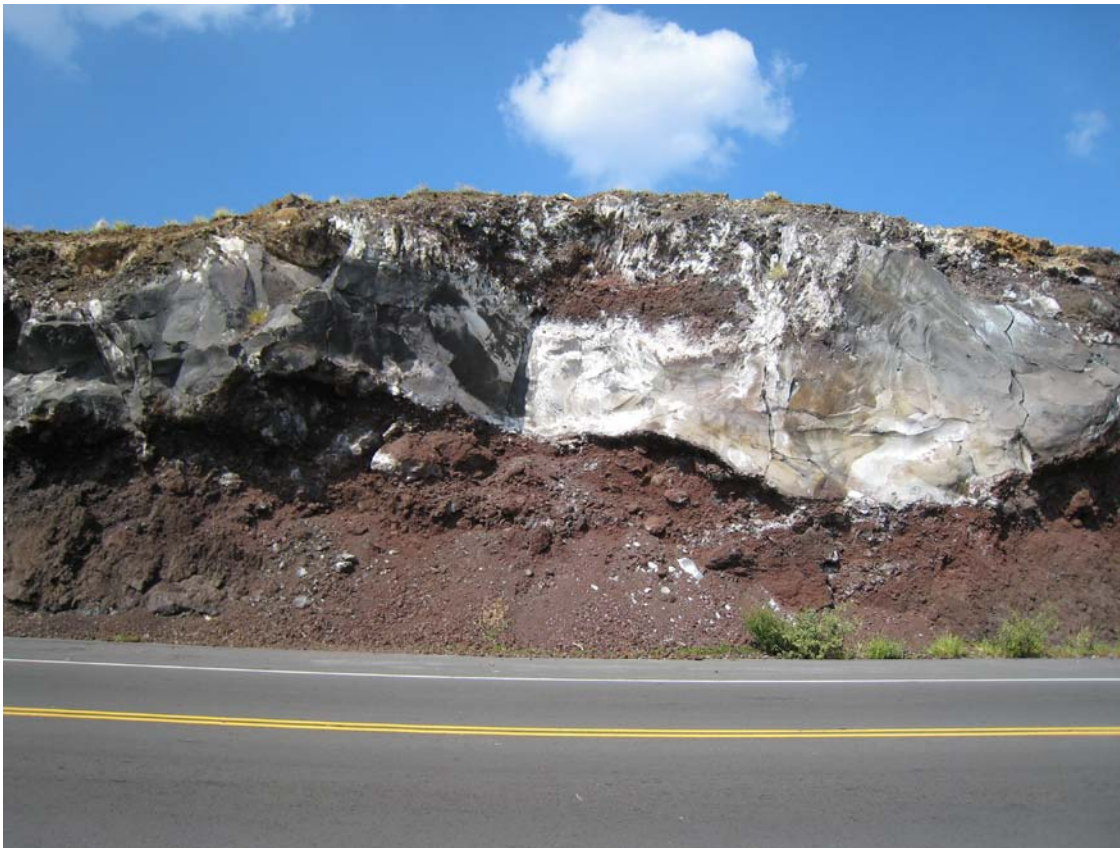
31.6–31.7. Close-up view of fracturing in the dense core of an ‘a‘ā flow (view to the west). USGS photo by T.J. Takahashi, 1/24/2009 (tjt1050, tjt1055).

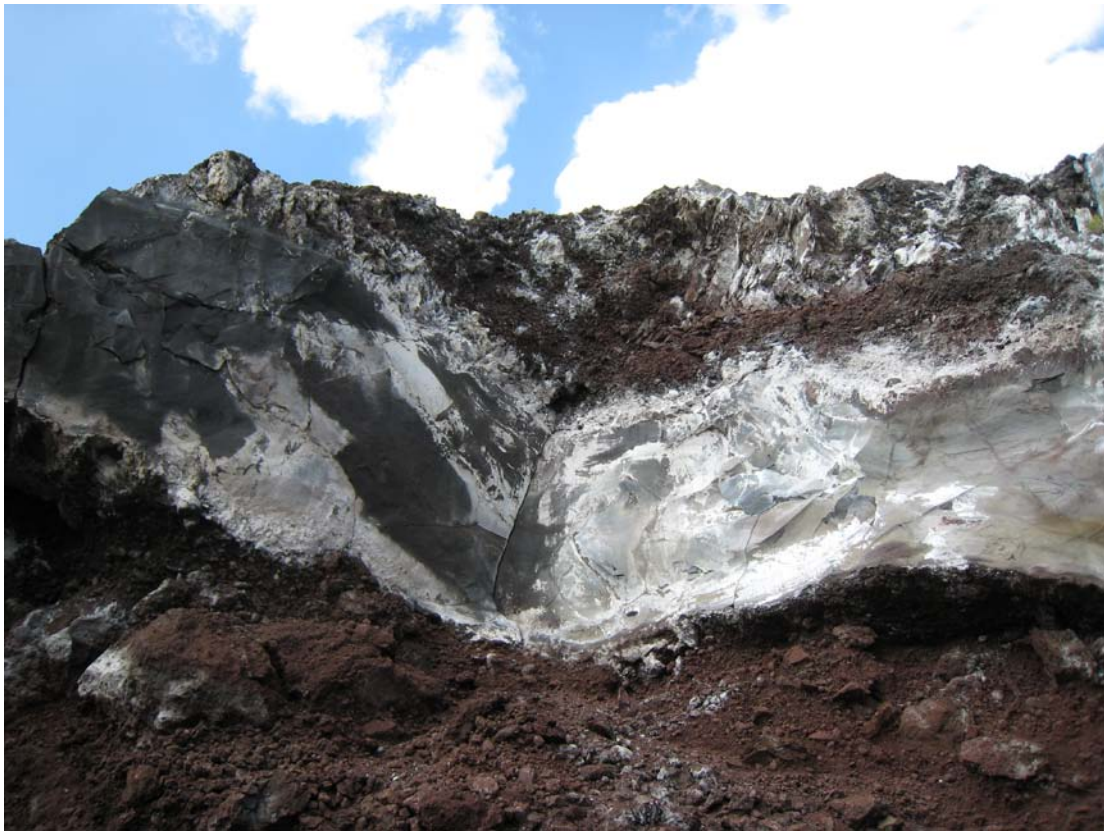
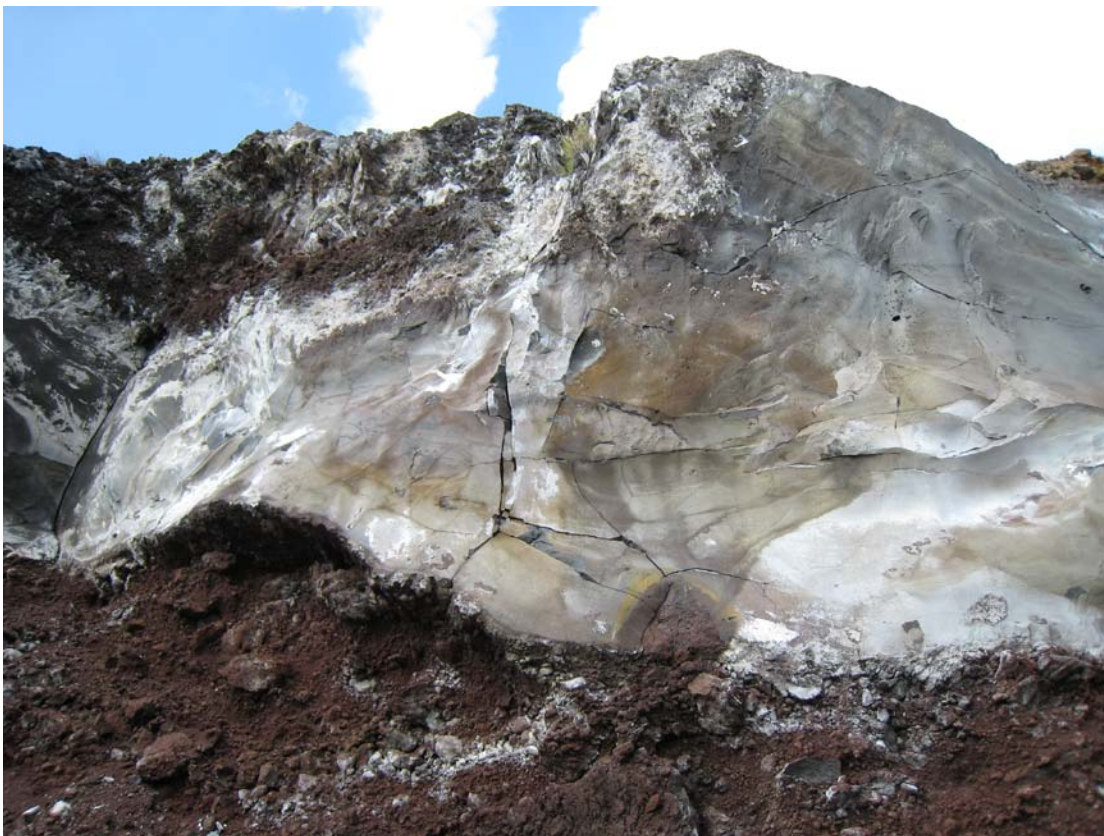
31.8–31.9. Close-up view of the dense core of an ‘a‘ā flow. Note the pattern and depth of vertical and horizontal fractures (view to the west). USGS photo by T.J. Takahashi, 1/24/2009 (tjt1100, tjt1099).

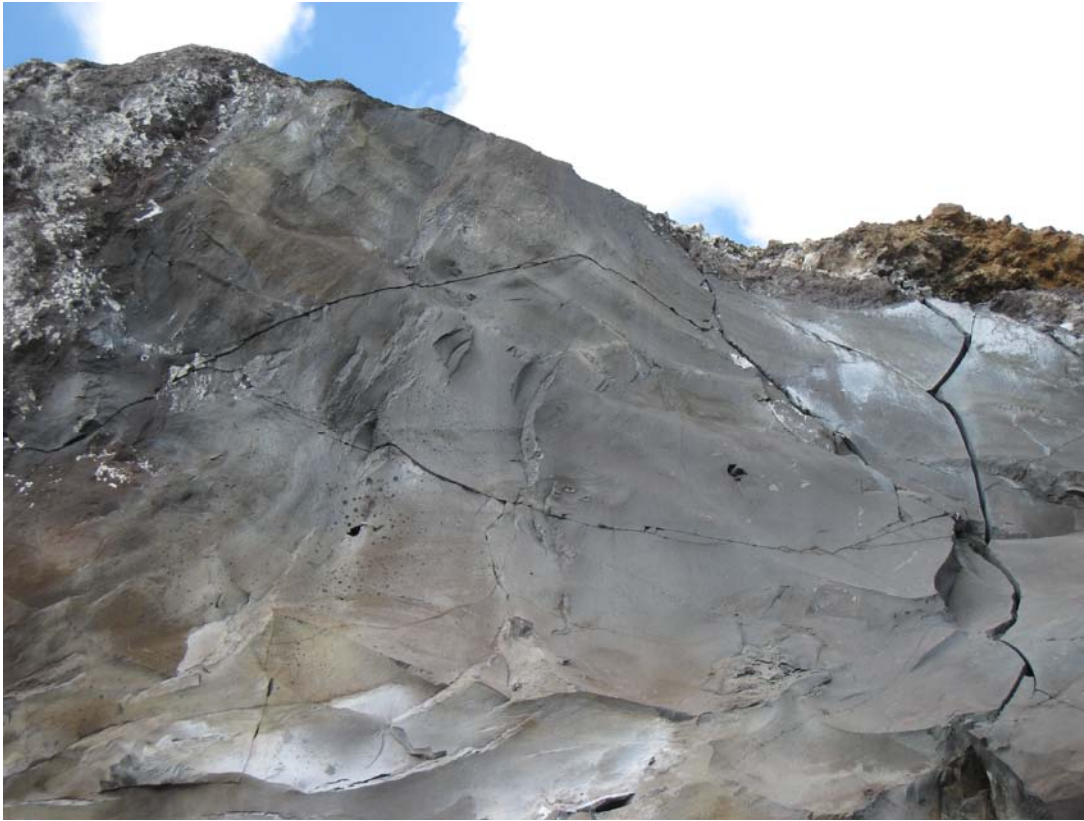
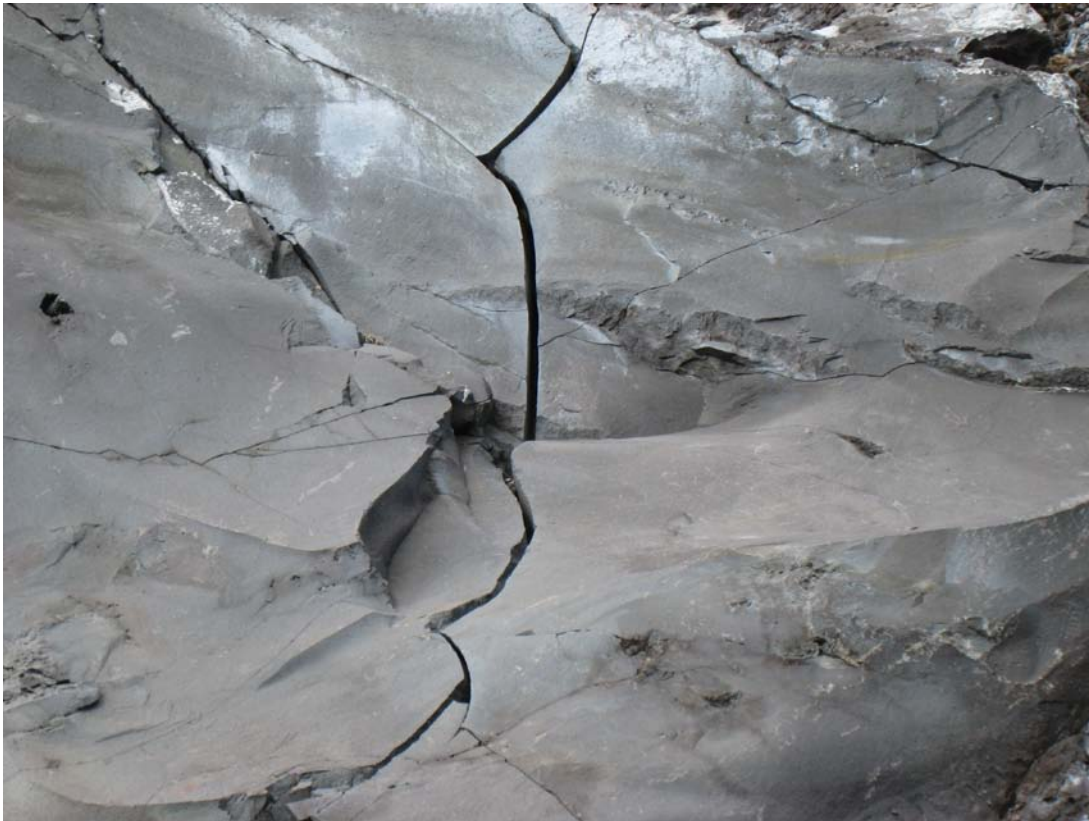
31.10–31.11. Detail of irregular fracturing in the dense core of an ‘a‘ā flow (view to the west). USGS photo by T.J. Takahashi, 1/24/2009 (tjt1098, tjt1096).

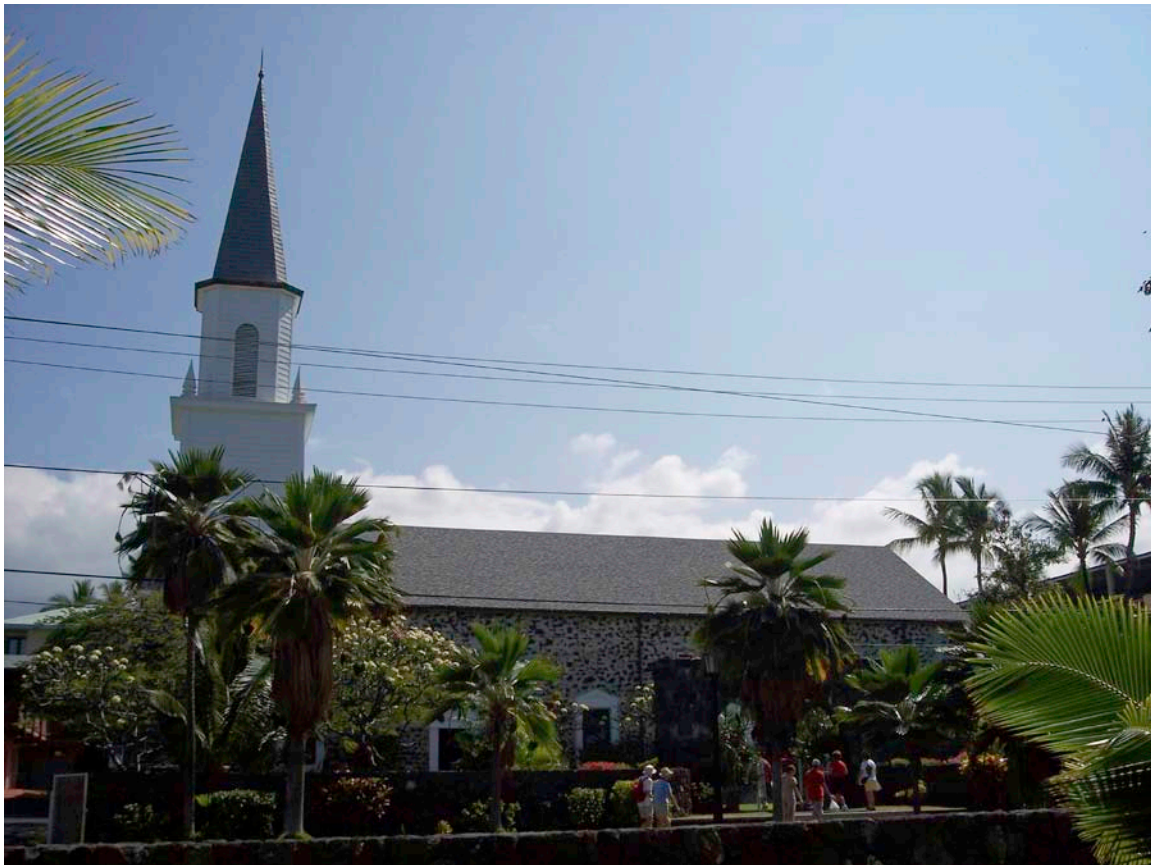
32.1. *Overview image:* Front entrance of Moku‘aikaua Church (view to the east). USGS photo by T.J. Takahashi, 3/23/2007 (tjt3314).

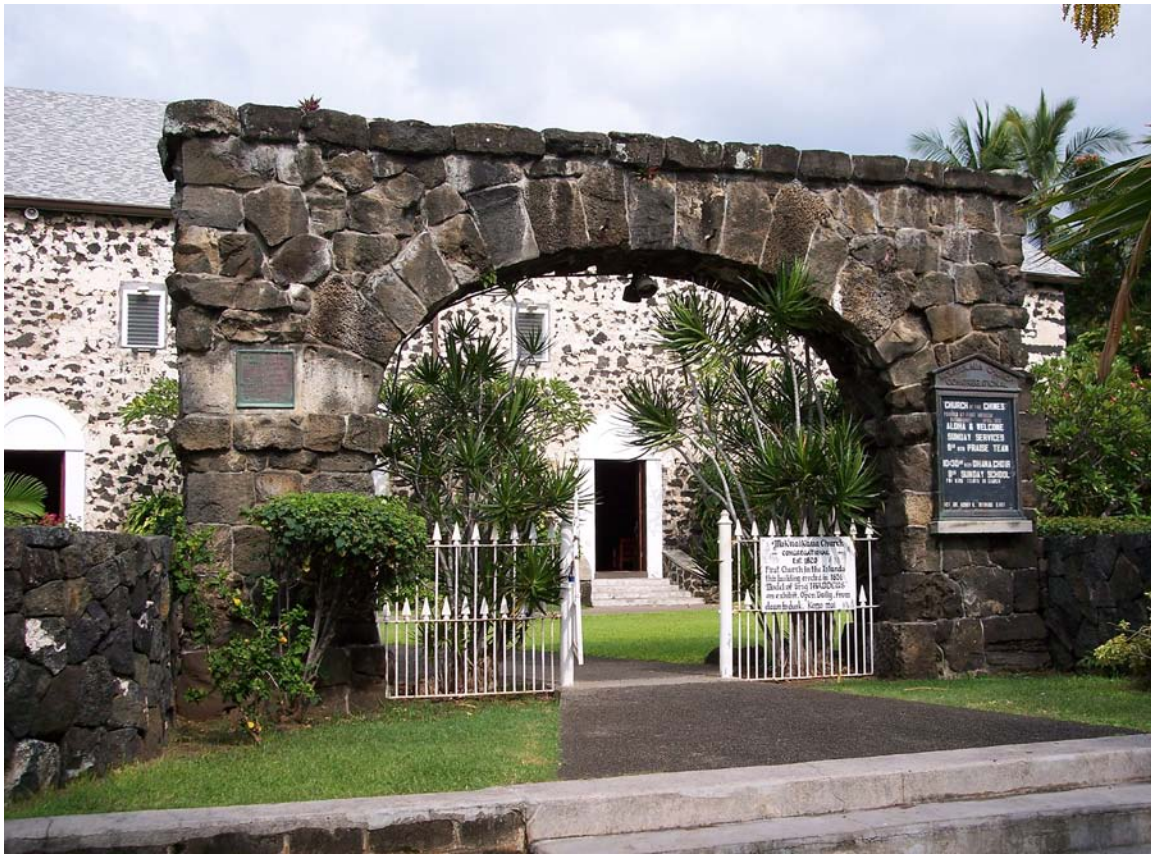
32.2. *Overview image*: Pāhoehoe lava slab archway, gate, and front entrance of Moku'aikaua Church (view to the east). USGS photo by T.J. Takahashi, 10/24/2006 (tjt1662).

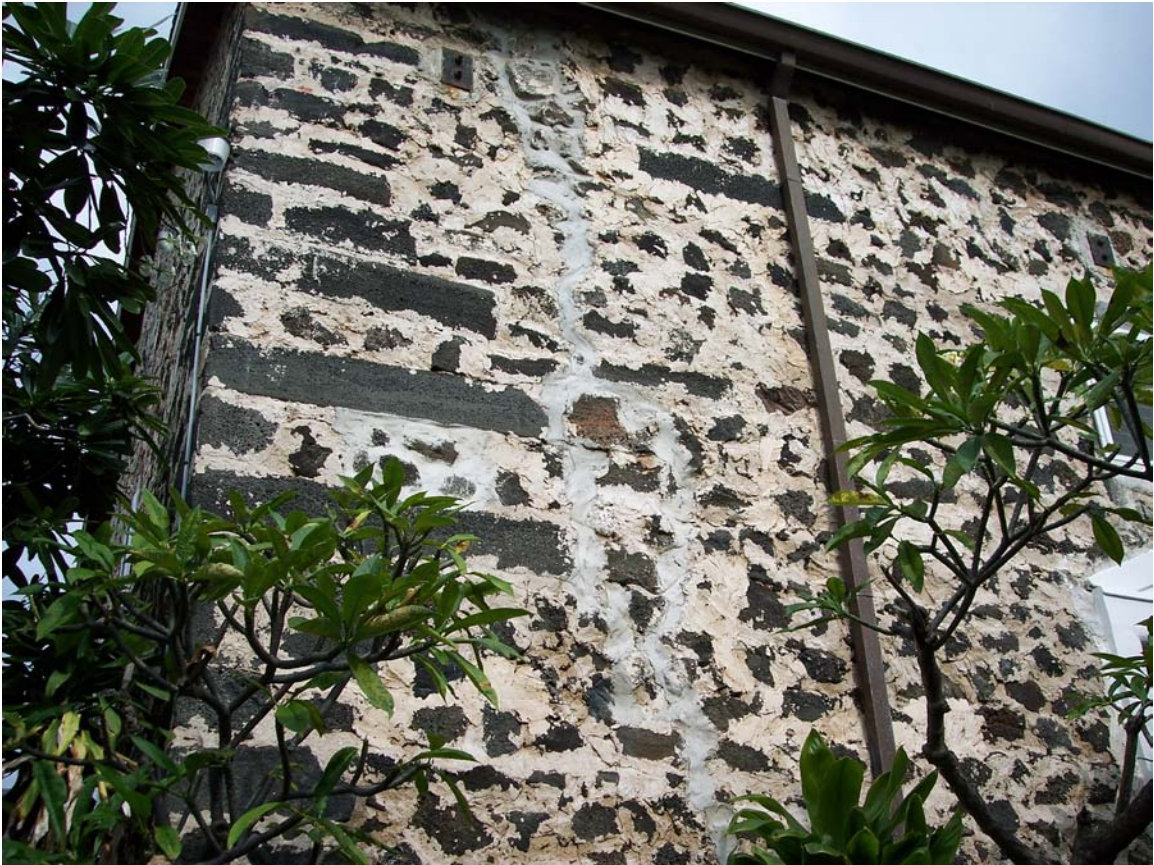
32.3. View of the repaired front exterior wall of Moku'aikaua Church, where grout was cracked from earthquake-related damage (view to the east-southeast). USGS photo by T.J. Takahashi, 10/24/2006 (tjt1667).

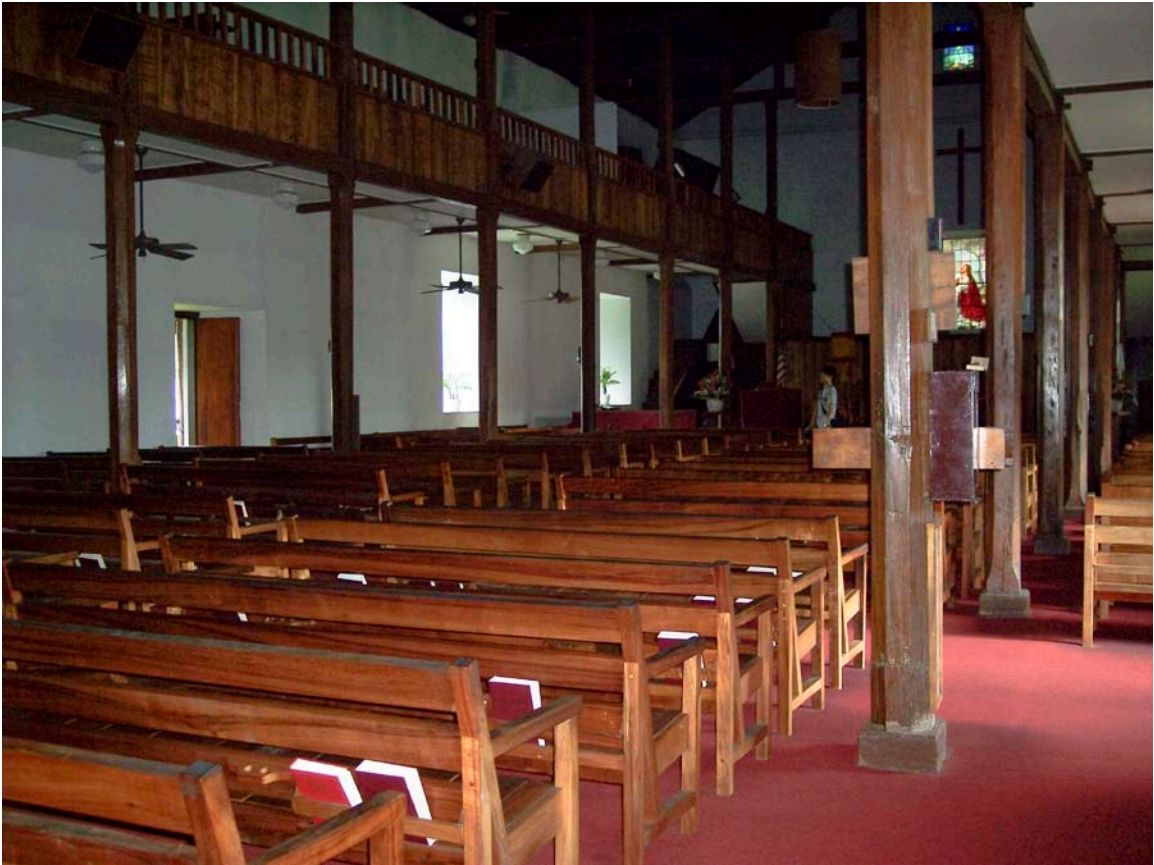
32.4. View of the undamaged interior of Moku'aikaua Church (view to the east). USGS photo by T.J. Takahashi, 10/24/2006 (tjt1671).

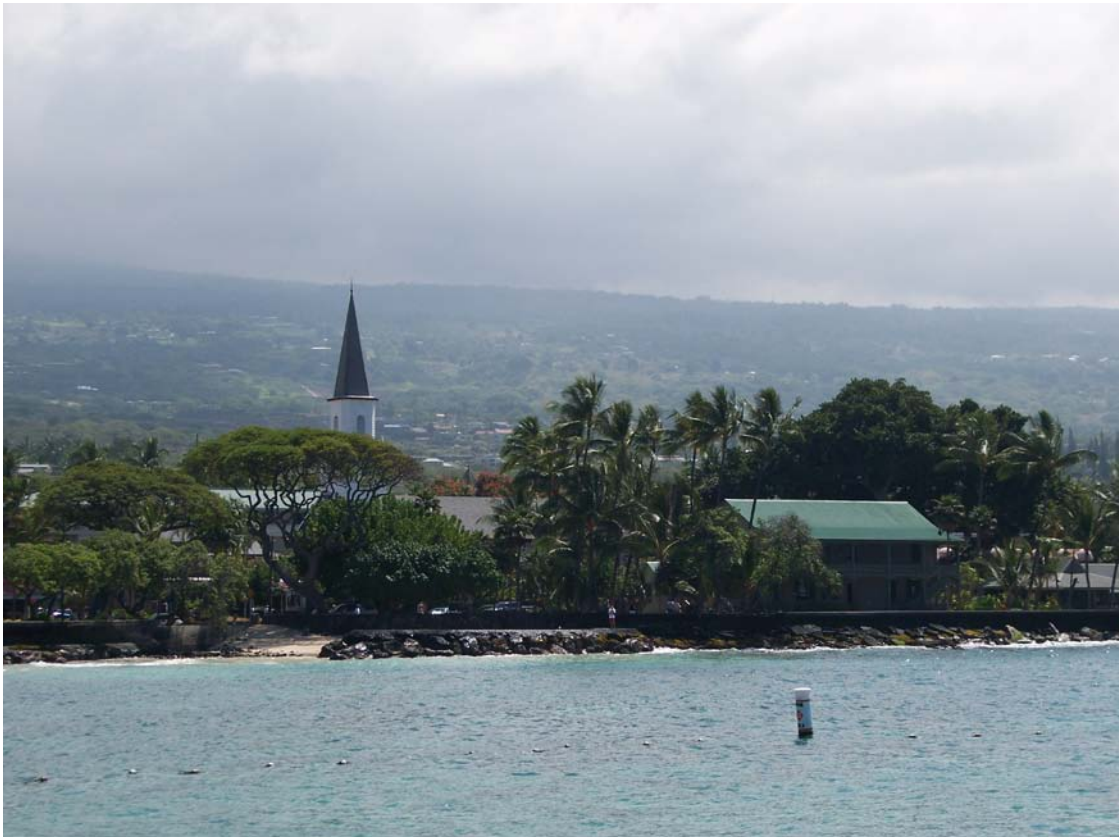
33.1. *Overview image:* Hulihe'e Palace (green-roofed structure) stands next to Moku'aikaua Church (building with the steeple), in vog-shrouded Kailua town, with Kailua Bay in the foreground (view from Kailua pier, looking east-northeast). USGS photo by T.J. Takahashi, 3/23/2007 (tjt3362).

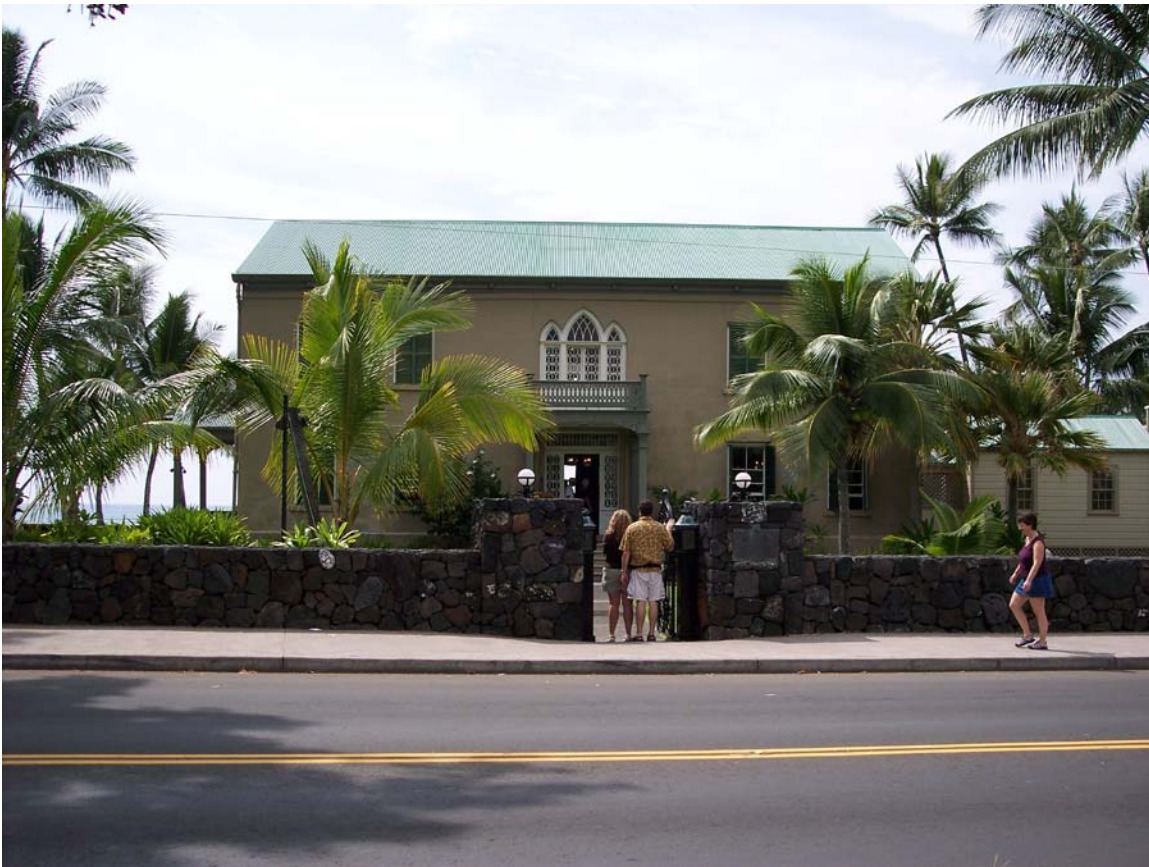
33.2. *Overview image*: Street-side and front-gate entrance to Hulihe'e Palace and grounds (view to the southwest, across from Ali'i Drive). Exterior views of the following photos (all but 33.11–33.18) take the viewer in a clockwise direction from this photo. USGS photo by T.J. Takahashi, 10/28/2006 (tjt1714).

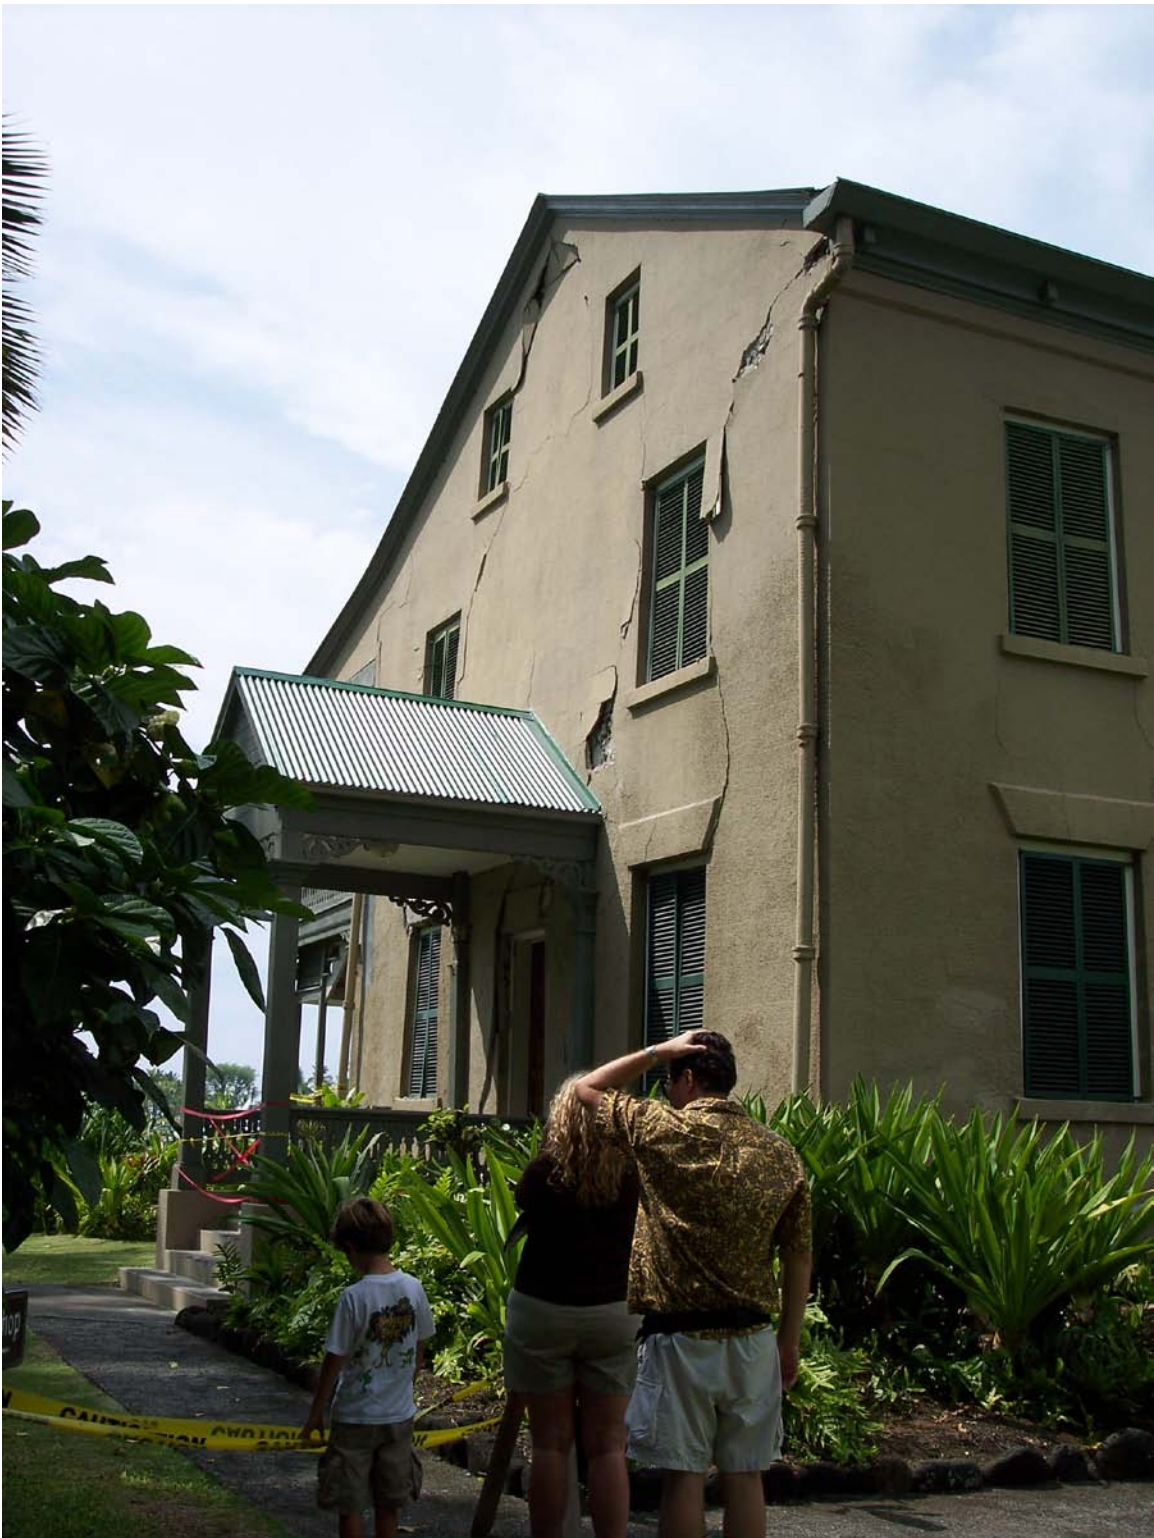
33.3. View of the damage to the exterior façade of the south gable at Hulihe'e Palace. The covered walkway is yellow-tagged for restricted use (view to the west). USGS photo by T.J. Takahashi, 10/28/2006 (tjt1716).

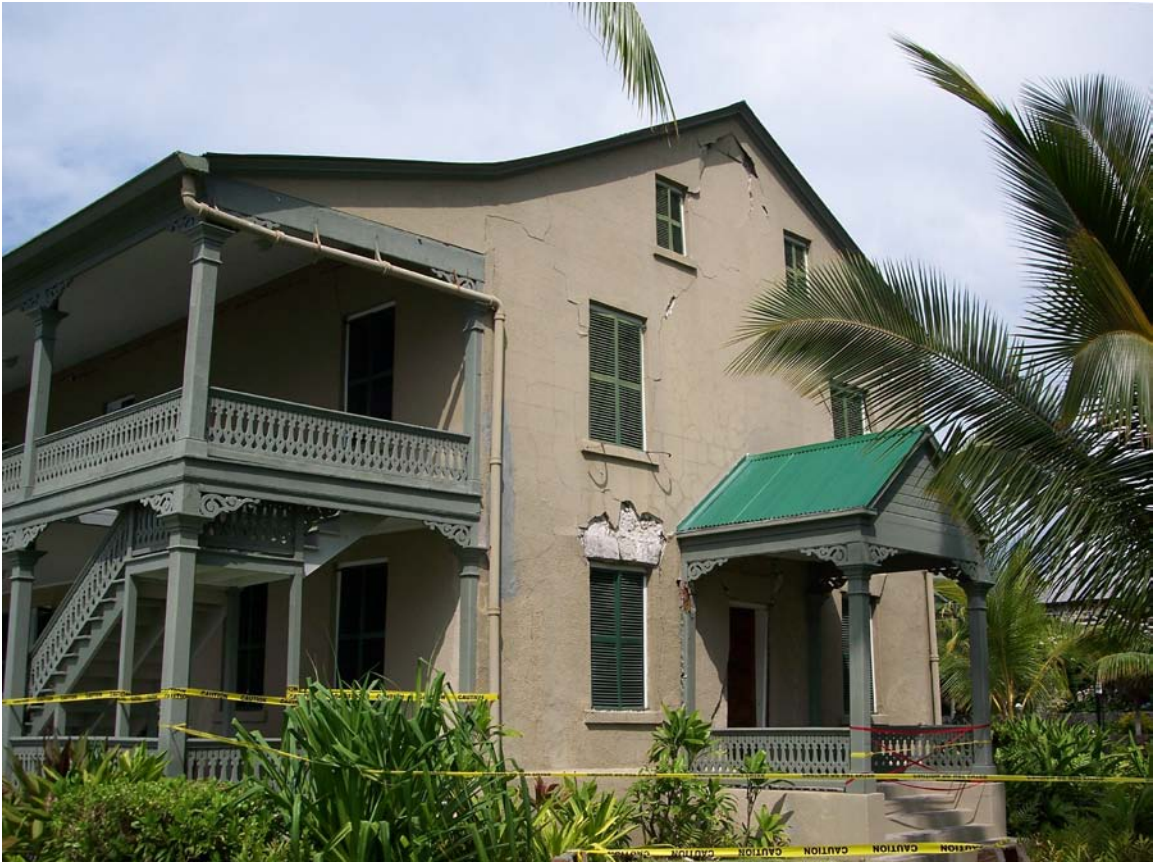
33.4. View of the damage to the exterior façade of the south gable at Hulihe'e Palace (view to the north). USGS photo by T.J. Takahashi, 10/28/2006 (tjt1738).

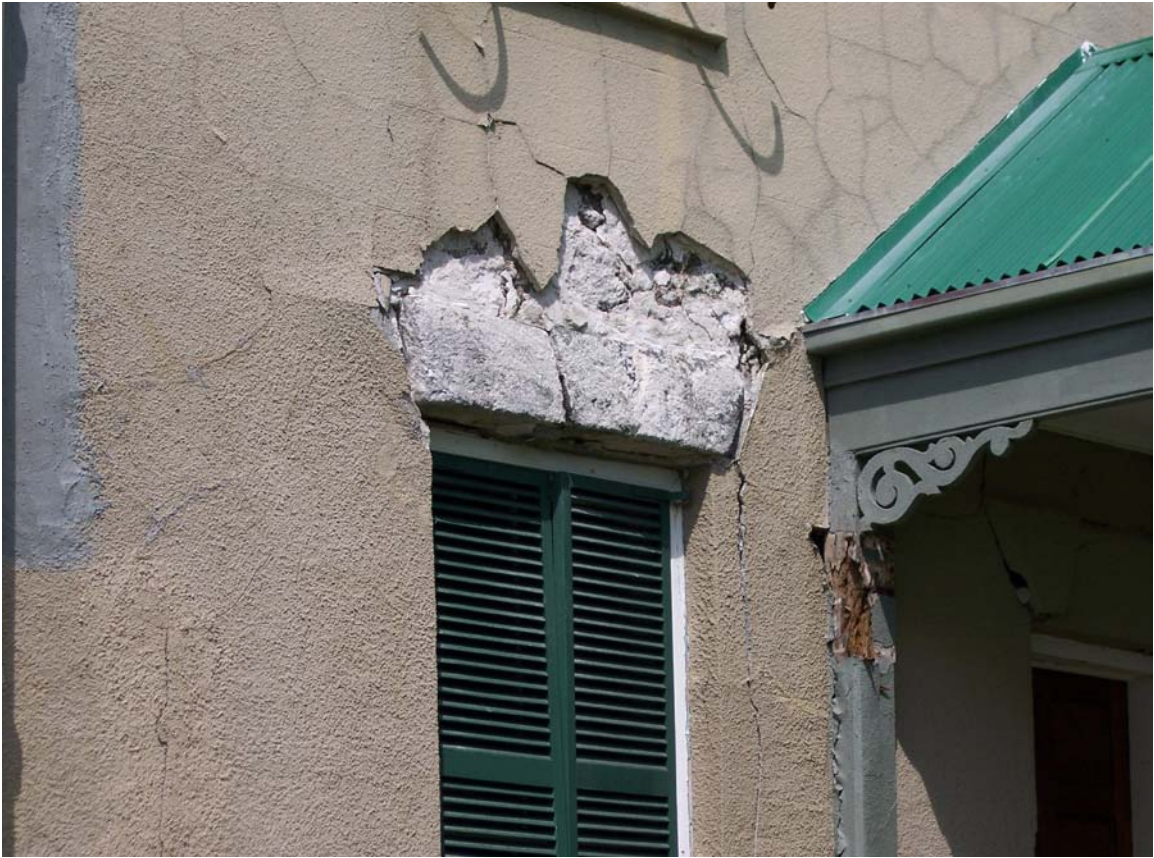
33.5. Close-up view of the damage to the façade above a south gable window (view to the north). USGS photo by T.J. Takahashi, 10/28/2006 (tjt1741).

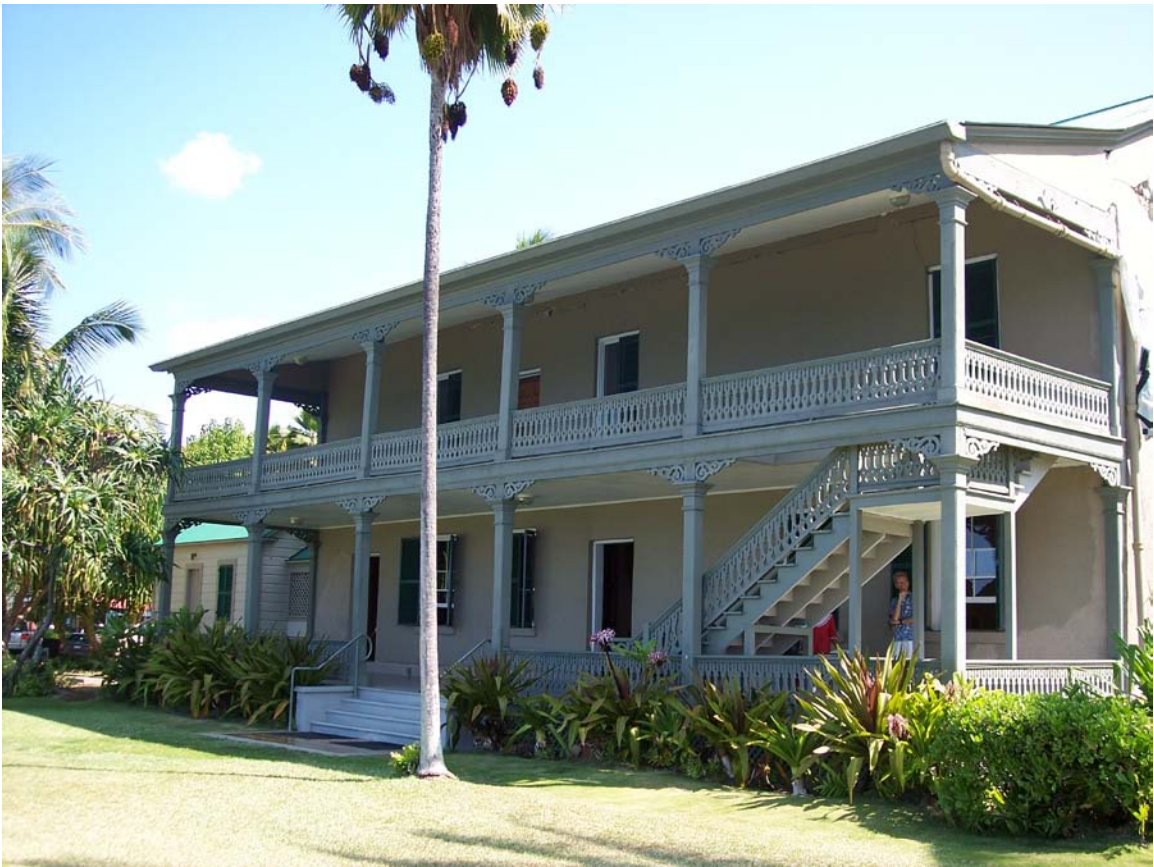
33.6. *Overview image*: The rear lānai (veranda), on the side opposite from the front gate, at Hulihe'e Palace (view to the north). USGS photo by T.J. Takahashi, 3/23/2007 (tjt3320).

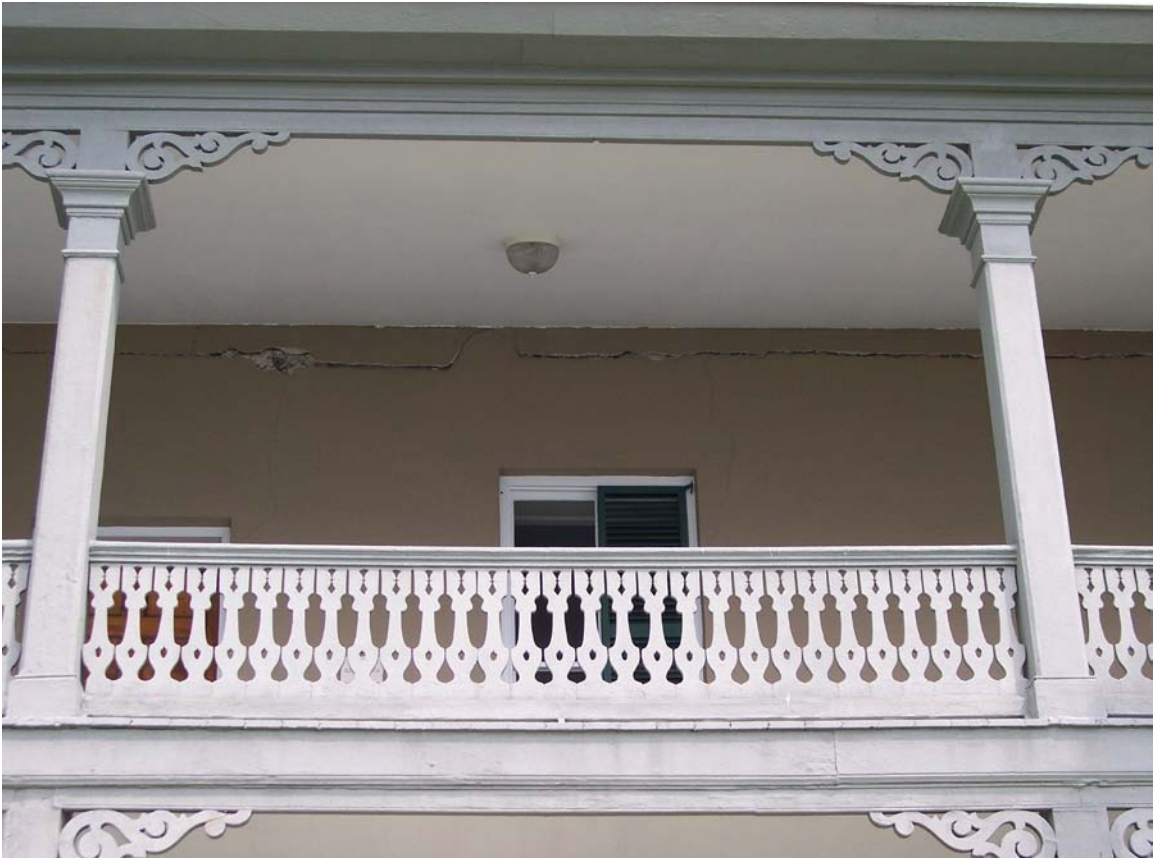
33.7. Close-up view of linear cracks in plaster along the entire length of the upper veranda at Hulihe'e Palace (view to the northeast from ground level). USGS photo by T.J. Takahashi, 10/28/2006 (tjt1733).

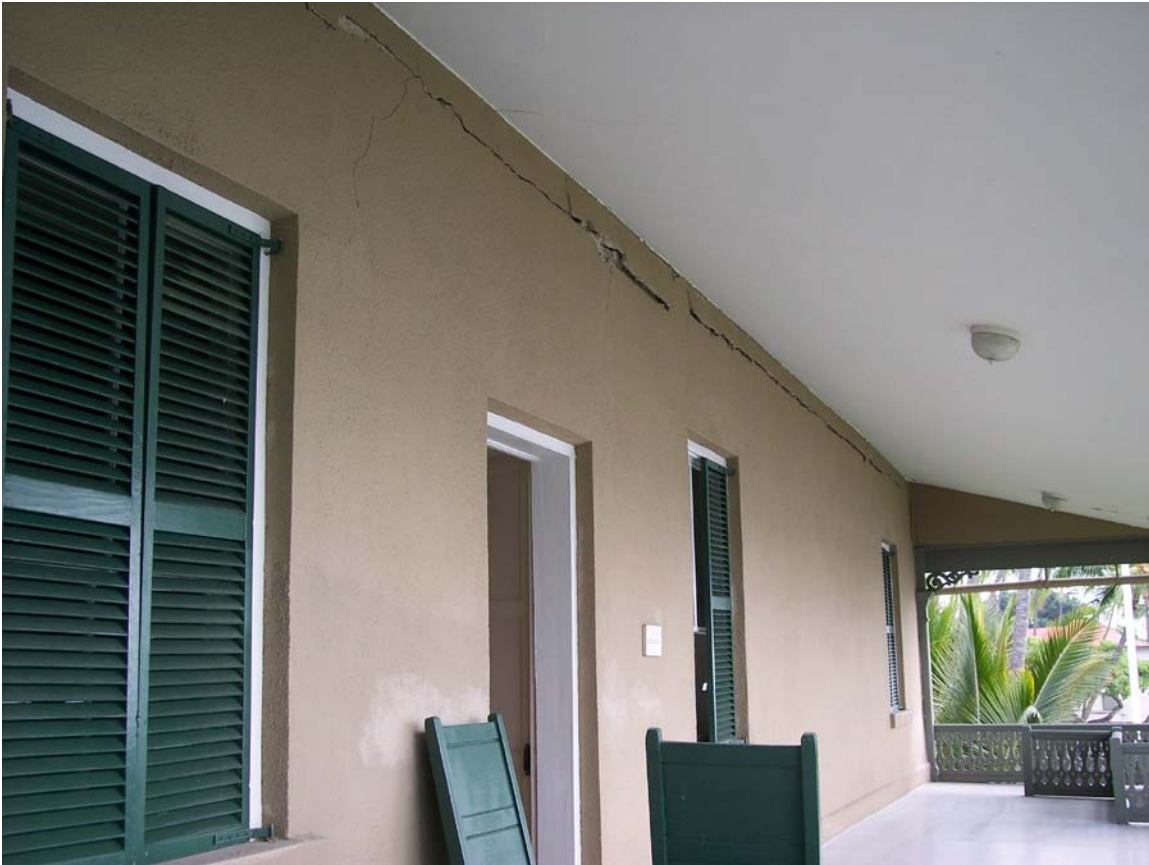
33.8. View of linear cracks in plaster along the entire length of the upper veranda, where the wall buckled outward (view to the east). USGS photo by T.J. Takahashi, 10/28/2006 (tjt1780).
